# Blue Belt

# Water Quality Expedition

# Survey Report

**Diego Garcia March/April 2019**

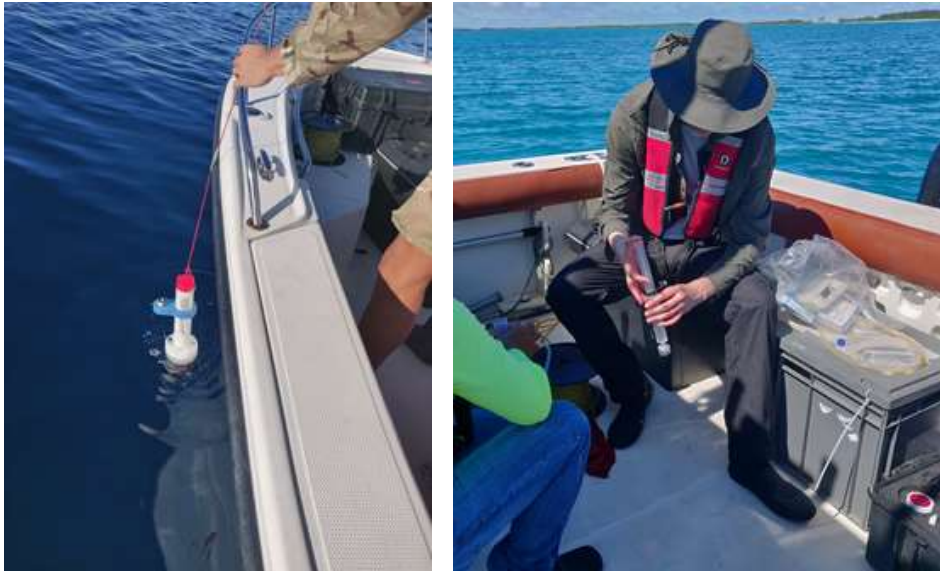
*Figure 4: Deployment of the CTD (left) and filtering a water sample for nutrient analysis (right).*

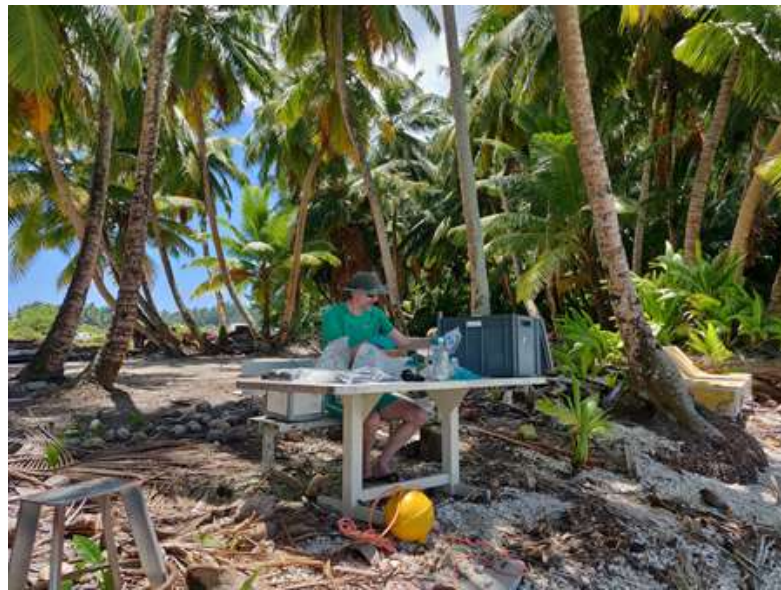
*Figure 5. Paul preparing the passive samplers before deployment.*
